Hawaii News

Waikiki sea wall failing, state says

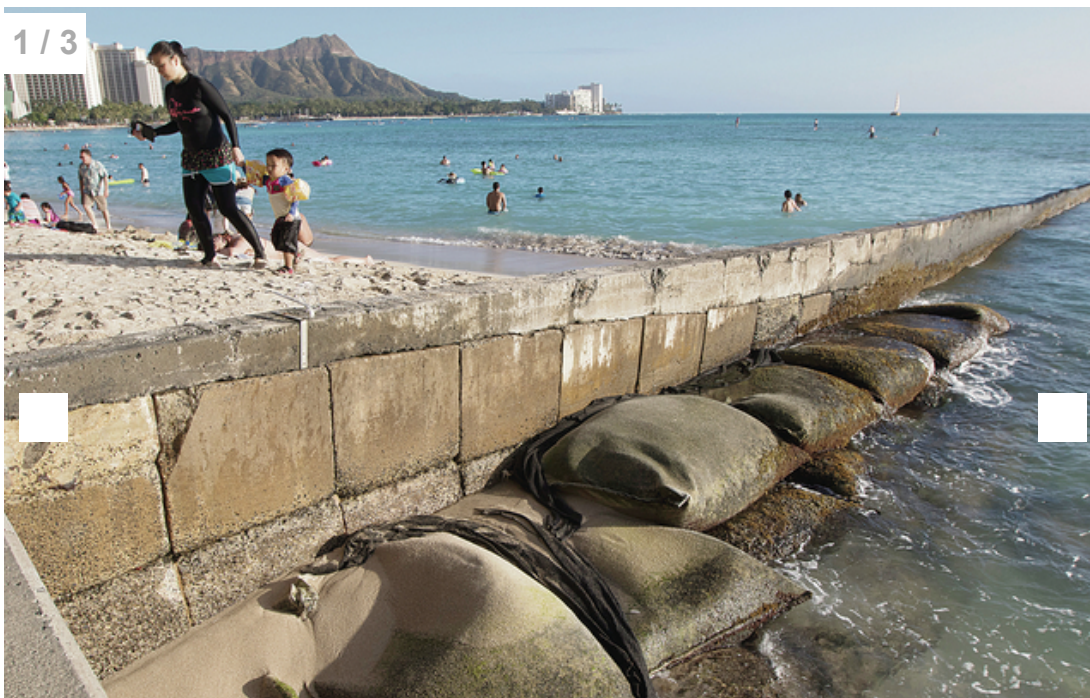
The concrete wall, or groin, between the Royal Hawaiian hotel and the Sheraton Waikiki at Waikiki Beach is reinforced with sandbags.

Much of the Royal Hawaiian Groin itself has been dislodged. About 205 feet of the 370-foot wall is submerged due to failure, with concrete blocks scattered about, according to DLNR's report.

DLNR attempted to shore up the groin after the sinkhole problem by stacking about 45 sandbags, each weighing 3,000 pounds, on the Ewa side of the wall's shoreward end to help prevent the wall, which is 8 feet high at its shoreward base, from toppling over. However, wave and current forces have displaced the top row of sandbags.
